**UNOSAT**

# UNOSAT analysis of destruction and other developments in Rakhine State, Myanmar

7 September 2018

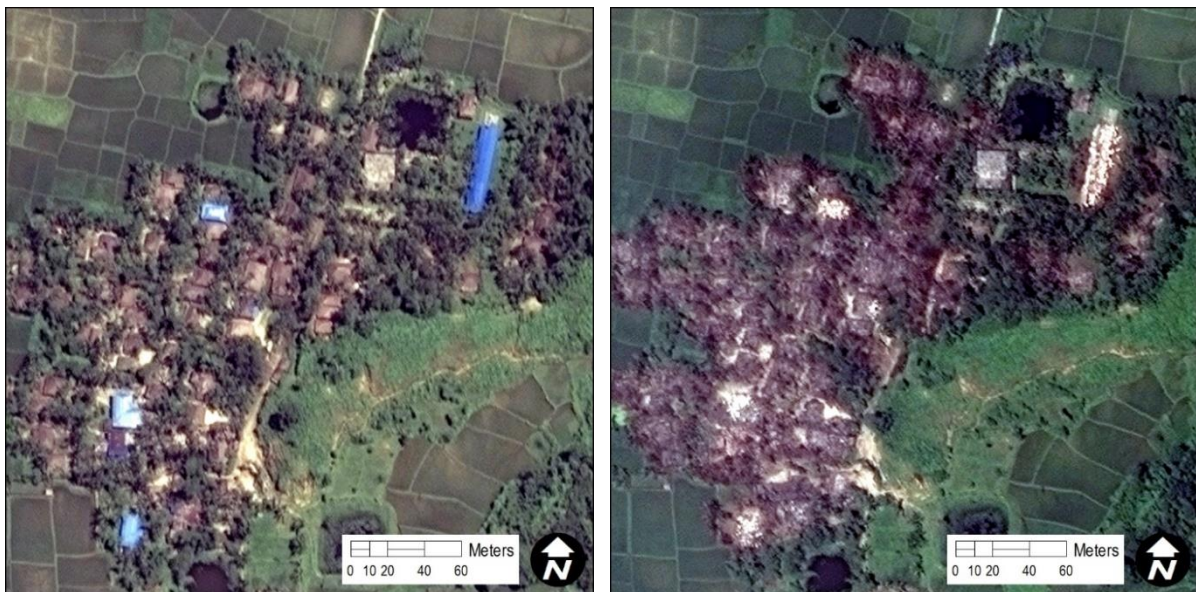
**Figure 1: Example of destruction caused by fire visible in satellite imagery**

These images show a portion of the village of Thauk Khu Lar (Song Khu Lar), Maungdaw Township, as of 25 September 2017 (left), with numerous building rooftops visible, varying in colour and size. By 1 October 2017 (right), all visible structures except for one located on the northeast have been completely destroyed. The presence of scorching and darkened soils in the areas where the structures used to be and the surrounding burned vegetation indicate that the destruction was caused by fire. Imagery courtesy of DigitalGlobe.

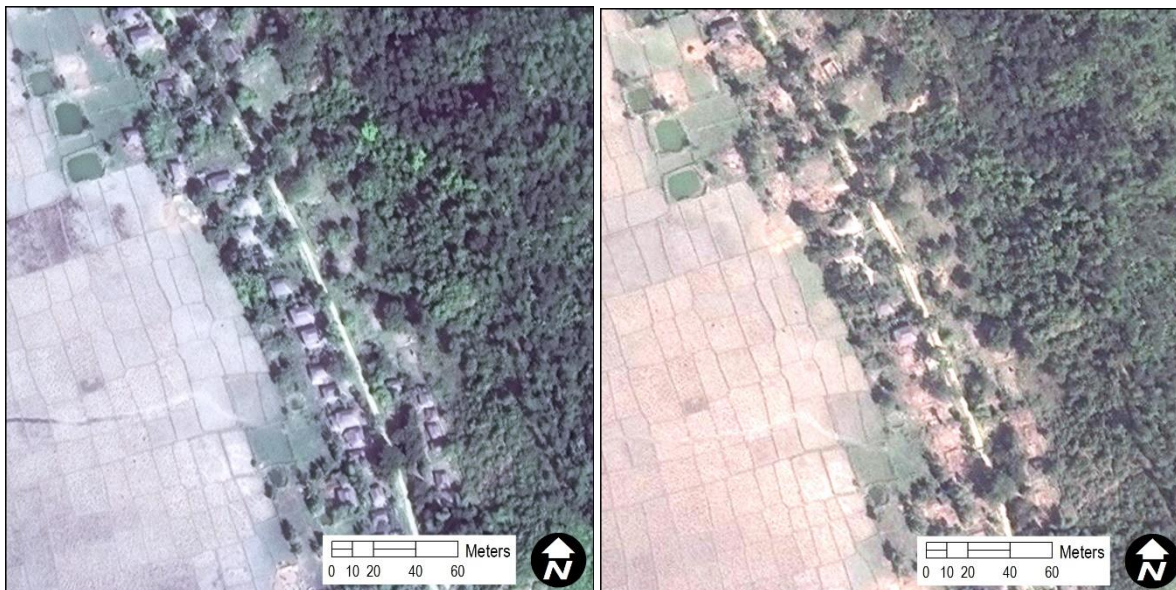
Figure 2: Example of destruction caused by demolition visible in satellite imagery

These images show a portion of the village of Maung Hla Ma, Buthidaung Township, as of 9 January 2018 (left), with numerous building rooftops visible. By 13 February 2018 (right), most of the visible structures have been completely destroyed. The presence of light colour debris and the absence of burned vegetation indicates that the cause of the damage did not involve fire and was more likely caused by some type of demolition. Imagery courtesy of DigitalGlobe

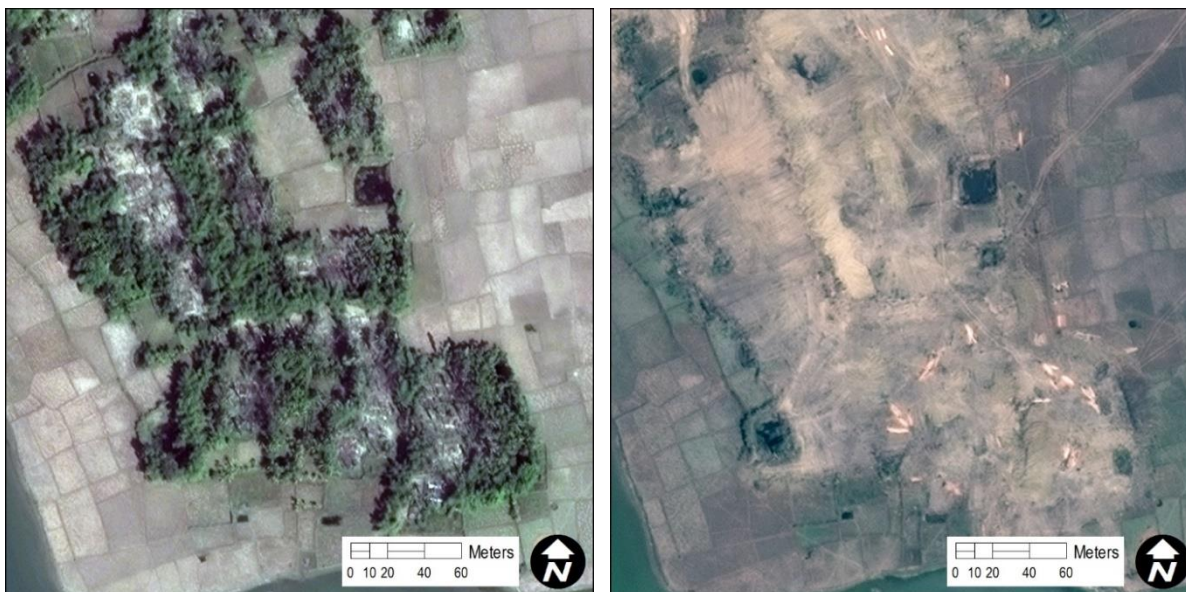
Figure 3: Example of debris clearing in satellite imagery

These images show a portion of the town of Doe Tan, Maungdaw Township, as of 9 January 2018 (left), with areas with signs of scorching and presence of debris. By 13 February 2018 (right), all visible debris has disappeared together with the surrounding vegetation indicating that the terrain has been cleared. Marks and tracks consistent with heavy equipment are also visible. Imagery courtesy of DigitalGlobe.

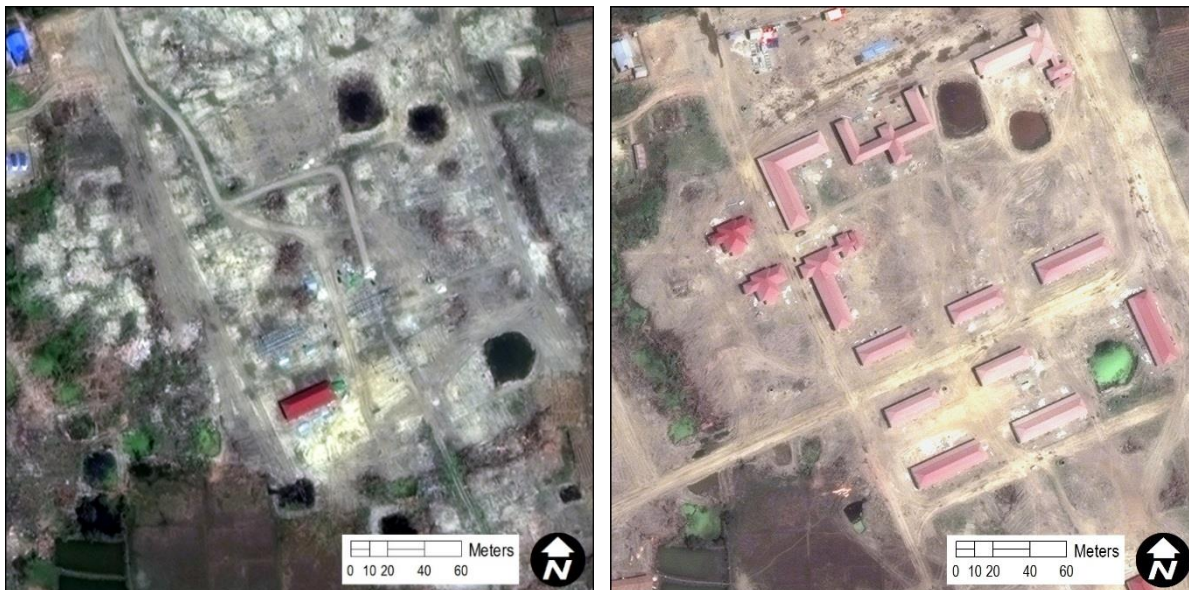
Figure 4: Example of construction in satellite imagery

These images show a portion of the town of Kan Kya (South), Maungdaw Township, as of 9 January 2018 (left), where there are visible signs of recent terrain clearance. By 27 February 2018 (right), at least 12 new buildings have been erected at the site. The presence of a defensive perimeter fence around the new buildings indicates that it is possibly a new security installation. Imagery courtesy of DigitalGlobe.

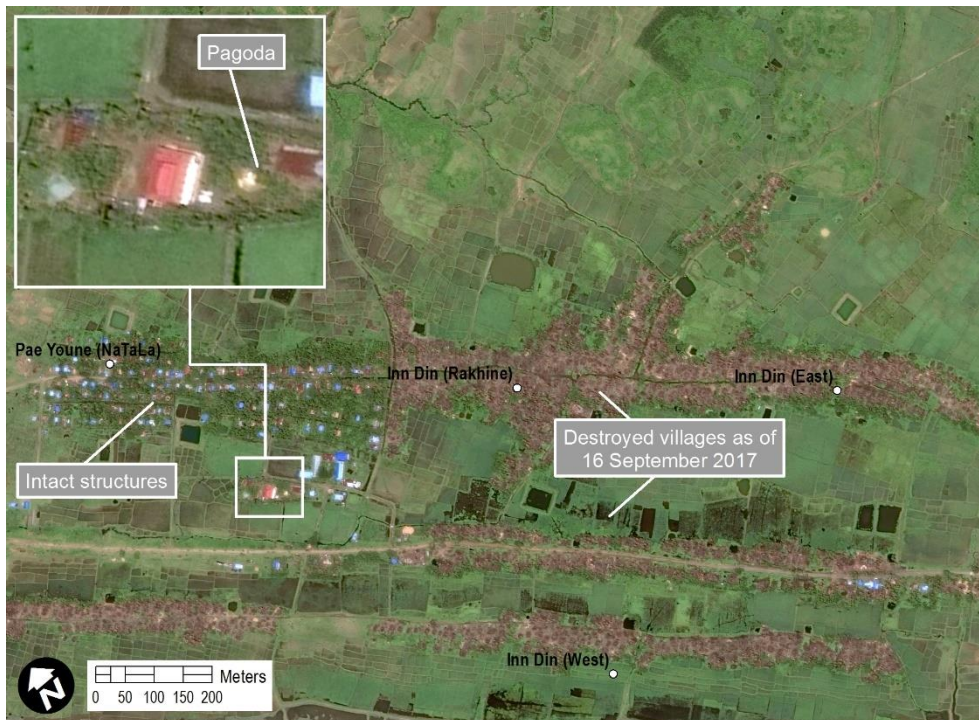
Figure 5: Pattern of destruction in Inn Din village tract, Maungdaw Township

UNOSAT analysis also showed that in several village tracts across Northern Rakhine, there is a repeated pattern in the damage where most of the settlements have been destroyed except for some villages that have a more structured design and different appearance of their buildings. Imagery shows the presence of pagodas in many of these villages which indicates the possible presence of Rakhine ethnic groups in those areas. This pattern is observed in the village tracts of Kha Maung Seik, Laung Don, Inn Din, Nyaung Chaung, (Du) Chee Yar Tan, Gaw Du Thar Ra (Ywar Thit Kay), War Cha, Ta Man Thar, Zaw Ma Tet, Kyauk Pan Du, Myo Thu Gyi, Min Gyi (Tu Lar Tu Li), Chein Hkar Li, Tha Yae Kone Tan, Done Paik (Aung Seik Pyin), Maung Hna Ma, U Daung, Nan Yar Kaing, Kyauk Pyin Seik, Kyee Kan Pyin and Tha Pyay Taw in Maungdaw township, Myauk Ye (a) Pan Be Chaung, Zee Hton, Tin May, Nga Yant Chaung (a) Taung Bazar and Thin Ga Net in Buthidaung Township and Zay Di Pyin, Koe Tan Kauk and Chut Pyin in Rathedaung Township. Figure 5 shows an example of this pattern of damage in the village tract of Inn Din, Maungdaw Township.

This image shows a portion of the village tract of Inn Din, Maungdaw Township, as of 9 October 2017, where satellite imagery shows that all the villages have been completely destroyed except for one of them that has a different appearance with more organized structures built with different materials, possibly with tin roofs. A pagoda is also visible in the intact area. Imagery courtesy of DigitalGlobe.

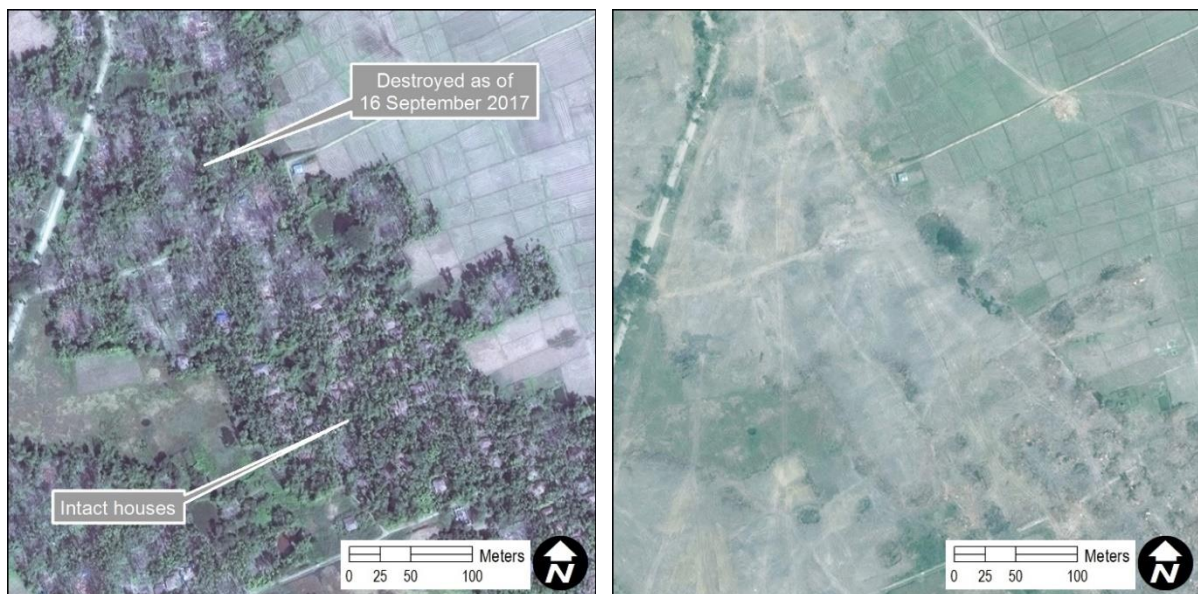
**Figure 6: Terrain clearance at Myin Hlut (East) village, Maungdaw Township**

Although in general the large scale bulldozing occurred on previously totally destroyed areas, UNOSAT identified that the clearing operations were also affecting groups of houses that appeared still intact in the almost totally destroyed villages. Examples of this pattern were observed in the villages of Chein Khar Li (West) in Chein Hkar Li village tract, Thaung Paing Nyar in War Cha village tract, Gaw Du Thar Ra (North) in Gaw Du Thar Ra (Ywar Thit Kay) village tract, Tat U Chaung in (Du) Chee Yar Tan village tract and Myin Hlut (Middle and East), Kan Nar Ywar Haung and Shee Dar in Myin Hlut village tract, Maungdaw Township. Figure 6 shows an example of this clearance in Myin Hlut (East).

These images show a portion of the town of Myin Hlut (East) village, Maungdaw Township, as of 9 January 2018 (left), where a large area of the settlement has been destroyed and a group of houses next to them appear intact. By 13 February 2018 (right), the whole area has been bulldozed or cleared and the previously intact structures are no longer visible. Imagery courtesy of DigitalGlobe.

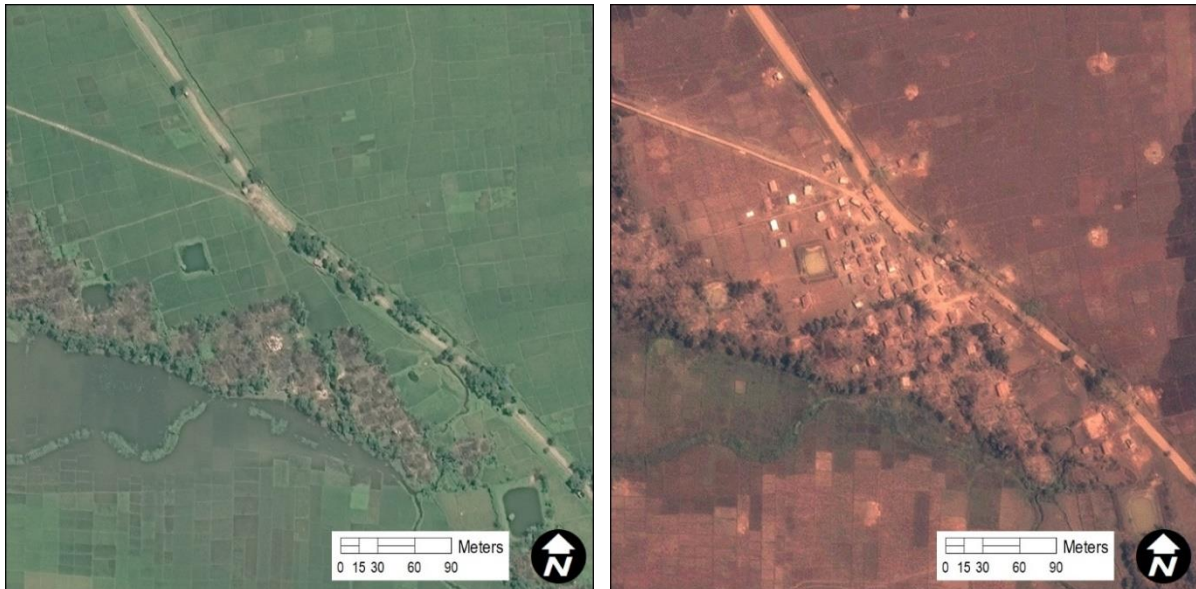
**Figure 7: Terrain clearance and new construction at Than Hpa Yar village, Maungdaw Township**

These images show Than Hpa Yar village, Maungdaw Township, on 25 September 2017 (left) and 7 March 2018 (right). As of 25 September 2017, the entire village was destroyed. Dark patches of soil indicate burning as the likely origin for the majority of damage. By 7 March 2018, several structures had been built over part of the affected village. Many more were visible on the agricultural fields surrounding the village, as well as along both sides of the main road. Imagery courtesy of DigitalGlobe.

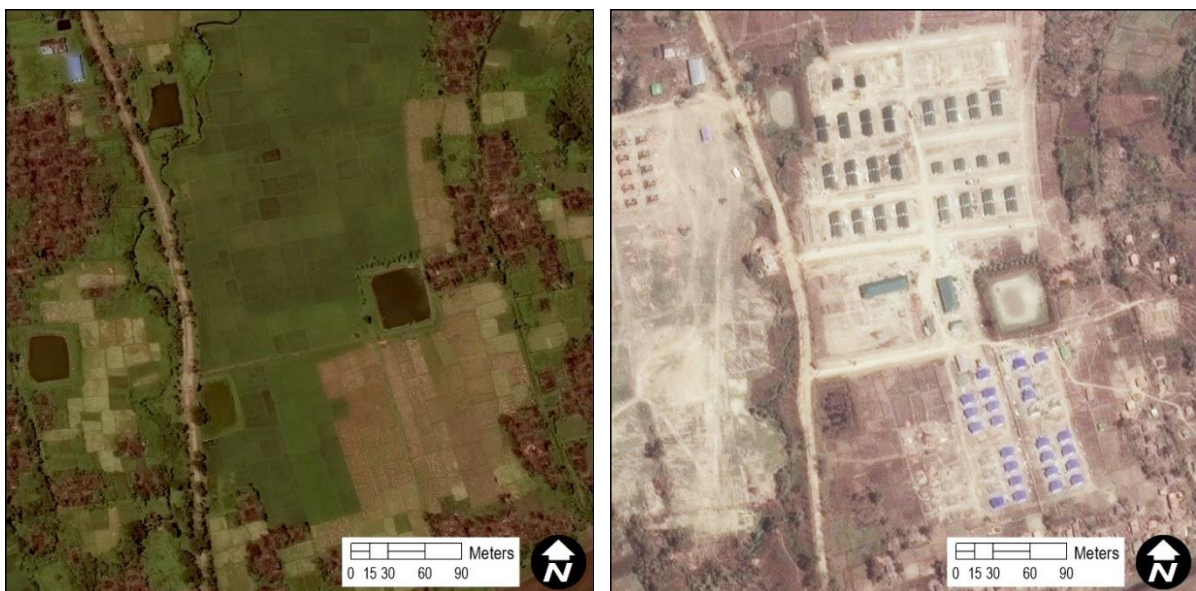
**Figure 8: Terrain clearance and new construction at Thit Tone Nar Gwa Son village, Maungdaw Township**

These images show Thit Tone Nar Gwa Son village, Maungdaw Township, on 11 October 2017 (left) and 7 March 2018 (right). Imagery shows that a large area of the terrain has been bulldozed, removing the debris from previously destroyed areas and new organized structures and roads have been built at the site. Imagery also shows the presence of smaller and less organized structures built directly in the previously damaged area. Imagery courtesy of DigitalGlobe.

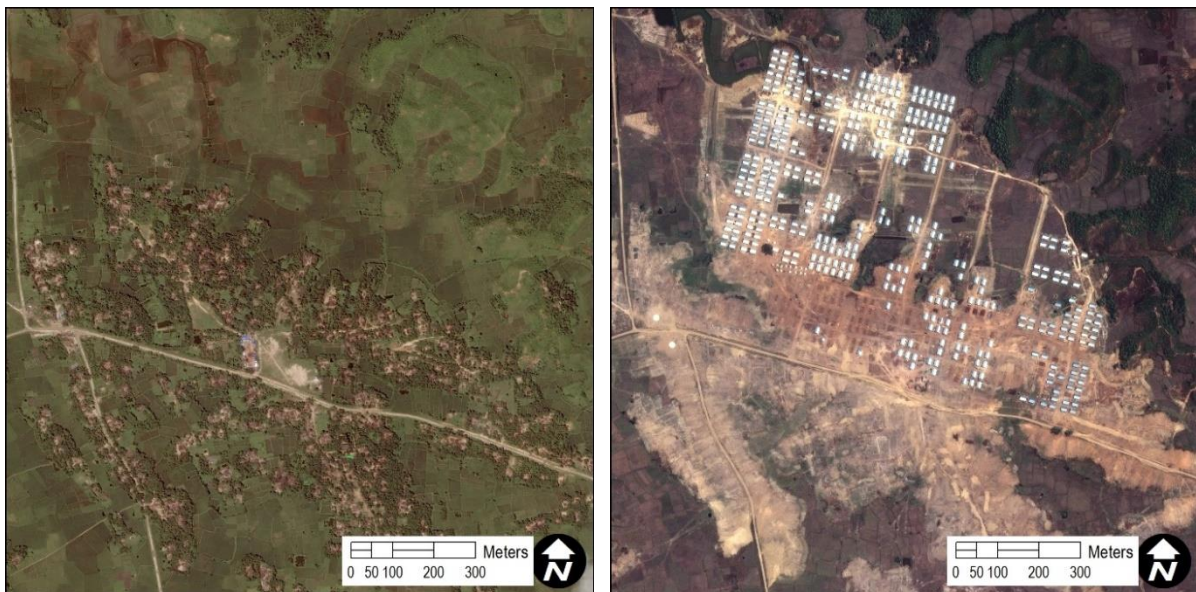
**Figure 9: Terrain clearance and new construction at Zin Paing Nyar village tract, Maungdaw Township**

These images show the villages of Haw Ri Tu Lar and Thar Zay Kone (Thar Zi Kone) in Zin Paing Nyar village tract, Maungdaw Township, on 11 October 2017 (left) and 18 March 2018 (right). Imagery from 18 March shows that a large area of the terrain has been bulldozed affecting previously damaged zones and also surrounding agricultural fields. New structures are being built in the bulldozed areas. Imagery courtesy of DigitalGlobe.

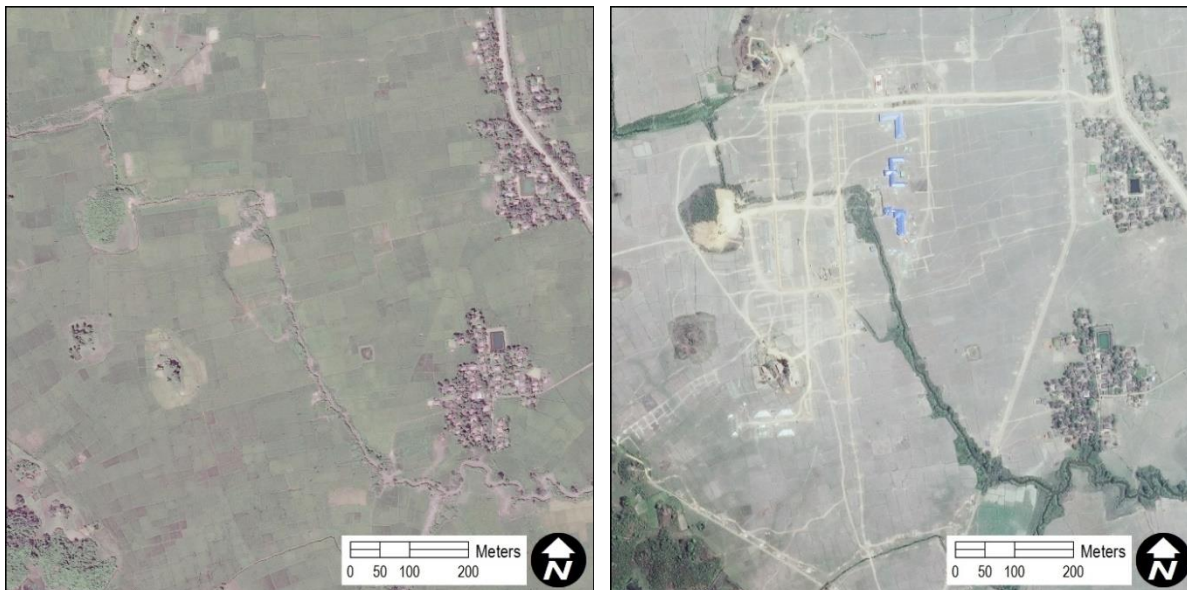
**Figure 10: Terrain clearance and new construction at Let Thar village, Buthidaung Township**

In the vicinity of the village of Let Thar, in Ah Lel Chaung village tract, Buthidaung Township, a new large construction site is visible as of March 2018 with new roads and structures being built (see Figure 10). The appearance of the buildings, with significantly larger size and the presence of a perimeter fence indicate that this is possibly a new security base under construction. In the village of Kan Kya (South), Myo Thu Gyi village tract, Maungdaw Township, imagery also shows that large structures are being built as well as a defensive perimeter fence. In this case, the new possible security base is constructed directly on the previously destroyed areas. This same pattern is observed in Inn Din village tract, Maungdaw Township, with new large structures directly constructed where previously destroyed houses used to be.

These images show Let Thar village, Ah Lel Chaung village tract, Buthidaung Township, on 11 October 2017 (left) and 18 March 2018 (right). Imagery shows the presence of a large construction site as of 18 March with newly built roads and large structures. The appearance of the structures being built and the presence of a fence around the area indicates that it could possibly be a new security base under construction. Imagery courtesy of DigitalGlobe.

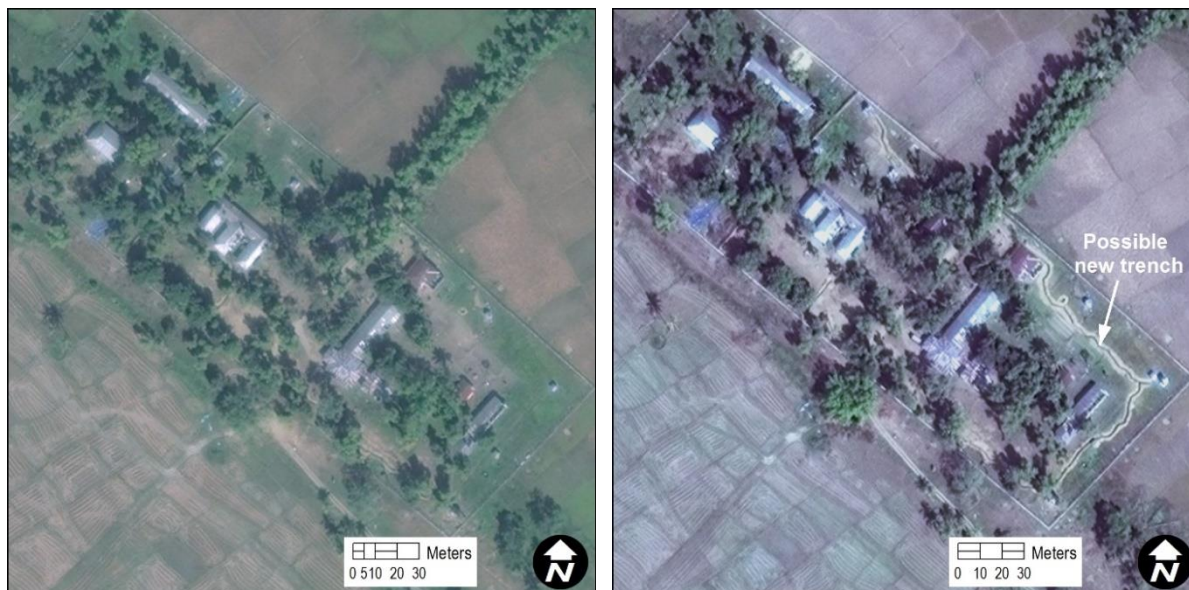
**Figure 11: Terrain clearance and new construction at Tha Pyay Taw village tract, Maungdaw Township**

These images show a military facility located in Tha Pyay Taw village tract, Maungdaw Township, on 2 December 2017 (left) and 9 January 2018 (right). Imagery shows the presence of a possible new trench constructed inside the limits of the compound. Imagery courtesy of DigitalGlobe.

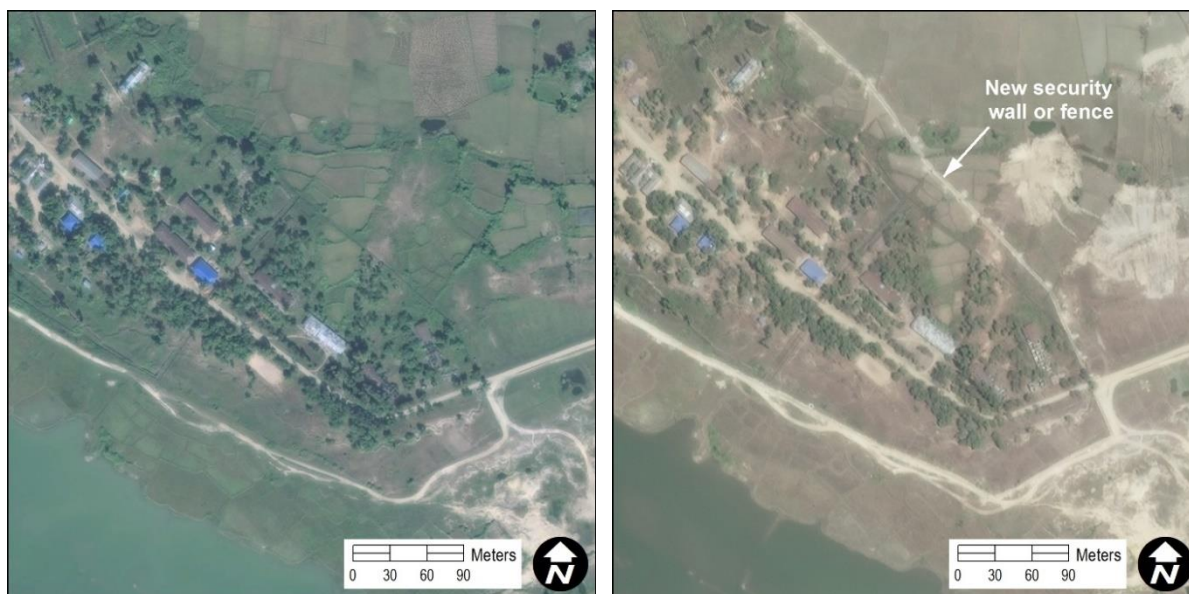
Figure 12: New defensive measures at a facility located in Kyauk Hlay Kar village tract, Maungdaw Township

These images show a security facility located in Kyauk Hlay Kar village tract, Maungdaw Township, on 2 December 2017 (left) and 20 February 2018 (right). Imagery shows the presence of a possible new defensive wall constructed inside the limits of the compound. Imagery courtesy of DigitalGlobe.

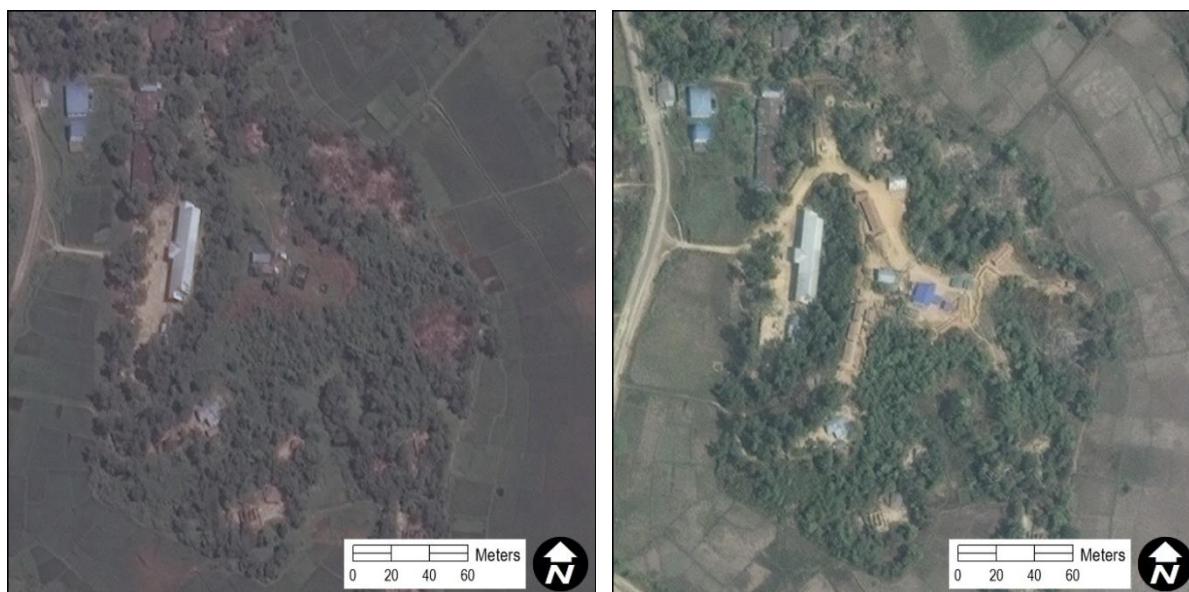
Figure 13: New security outpost located at Aung Zay Ya (Nyein Chan Yay) in Aung Zay Ya (Nyein Chan Yay) village tract, Maungdaw Township

These images show a new facility located nearby Aung Zay Ya (Nyein Chan Yay) in Aung Zay Ya (Nyein Chan Yay) village tract, Maungdaw Township, on 25 September 2017 (left) and 7 March 2018 (right). Imagery shows the presence of a new area of terrain cleared where new structures have been built and are surrounded by a defensive trench. Imagery courtesy of DigitalGlobe.

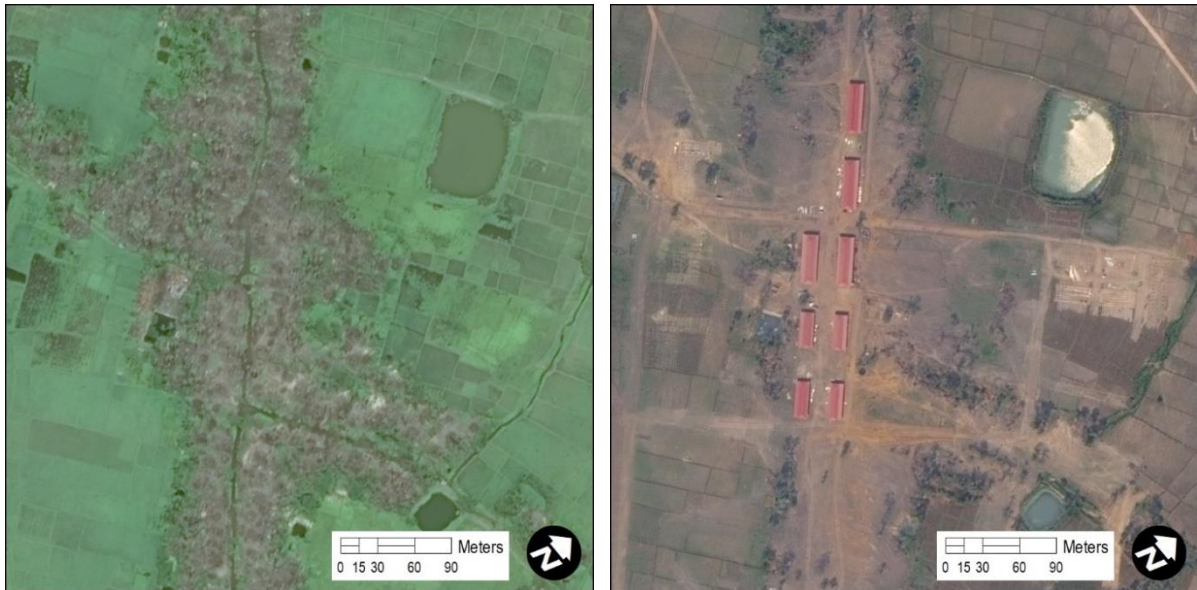
**Figure 14: Terrain clearance and new construction in Inn Din (Rakhine) village, Maungdaw Township**

The images above show part of Inn Din (Rakhine) village, Maungdaw Township, on 9 October 2017 (left) and 7 March 2018 (right). The village was destroyed as of 9 October 2017, with dark soil as indication of fire as the cause. By 7 March 2018, the majority of affected terrain had been cleared and several large structures built. New roads and foundations for further construction were also visible in another impacted area and surrounding agricultural fields. Imagery courtesy of DigitalGlobe.

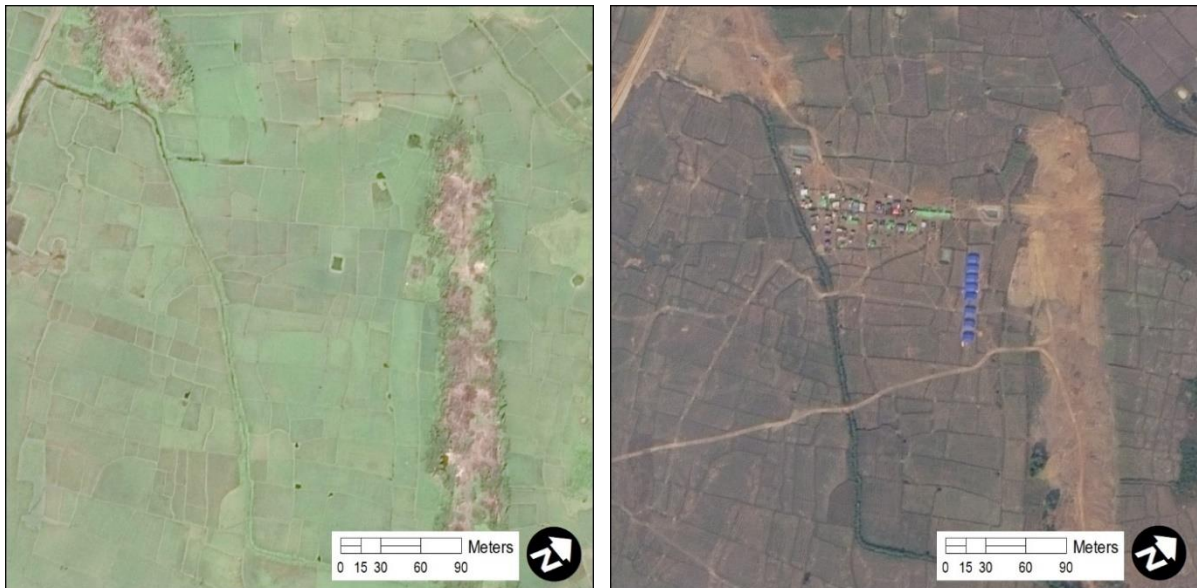
**Figure 15: Terrain clearance and new construction at Inn Dinn (Middle) village, Maungdaw Township**

These images illustrate the southern portion of Inn Din (Middle) village, Maungdaw Township, on 9 October 2017 (left) and 7 March 2018 (right). As of 9 October 2017, this part of the village was destroyed with burn marks visible where houses previously stood. By 7 March 2018, the affected area appeared to have been bulldozed. A few new roads and several small possible temporary structures were visible between the two cleared zones. Imagery courtesy of DigitalGlobe.

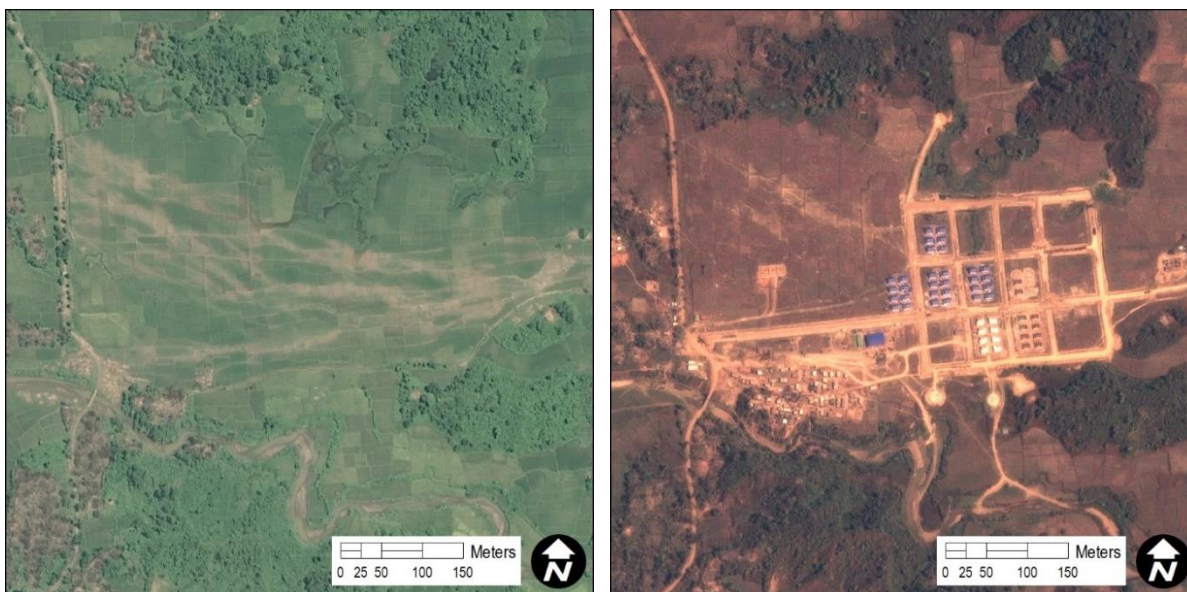
**Figure 16: New development site visible at Pa Da Kar Taung village, Maungdaw Township**

The images above show the southern part of Pa Da Kar Taung village, Maungdaw Township, and its surrounding area on 25 September 2017 (left) and 7 March 2018 (right). Burned areas in this village and Pa Da Kar Ywar Thit village to the south were visible as of 25 September 2017. By 7 March 2018, some of Pa Da Kar Taung village appeared to have been cleared and many small structures built. Agricultural fields to the east were converted into a development site consisting of several new roads, larger structures, foundations, and two helipads. Imagery courtesy of DigitalGlobe.

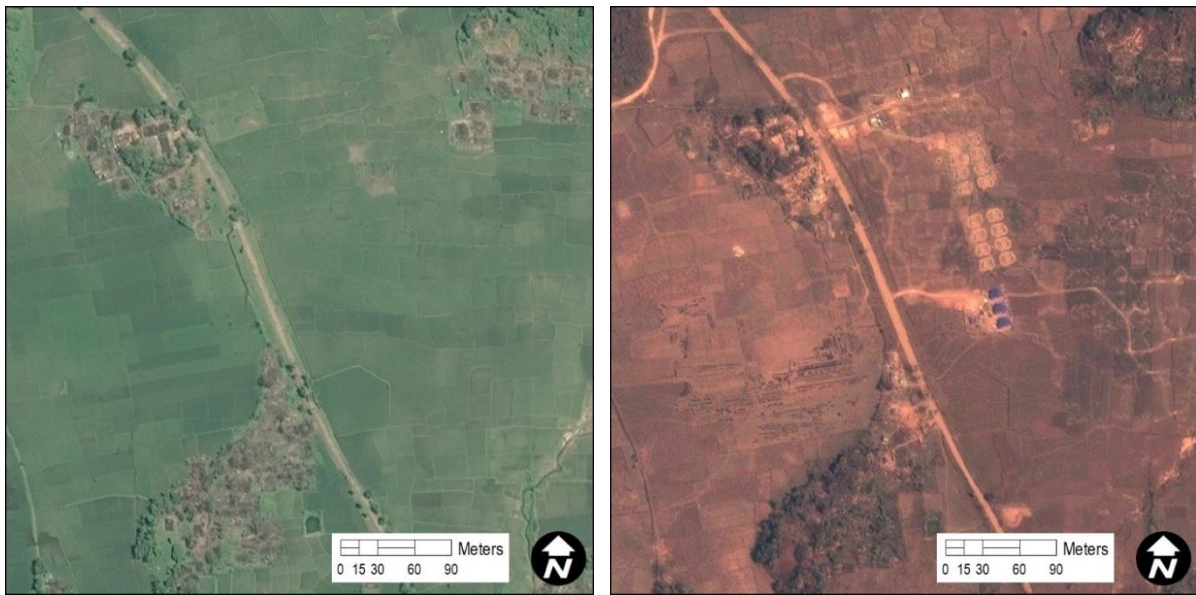
Figure 17: Terrain clearance and new construction at Pa Da Kar Ywar Thit village, Maungdaw Township

The images above illustrate southern Pa Da Kar Ywar Thit village, Maungdaw Township, on 25 September 2017 (left) and 7 March 2018 (right). This portion of the village was destroyed as of 25 September 2017, with visible scorching marks from fire. By 7 March 2018, some small structures appeared over affected areas near the main road. East of the village, a development site with a few new roads, structures and several foundations was visible over agricultural fields. Imagery courtesy of DigitalGlobe.

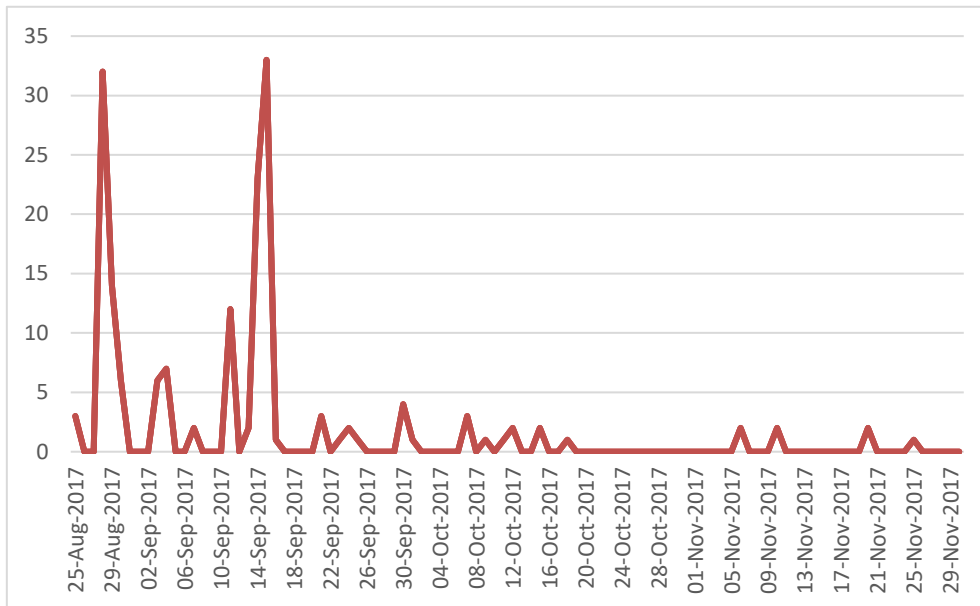
Figure 19: Daily sum of satellite-detected fires, 25 August – 30 November 2017

This graph shows the daily totals of fire detections in Rathedaung, Buthidaung and Maungdaw Townships between 25 August and 30 November 2017, with the highest number of detections occurring on 28 August and 15 September 2017.

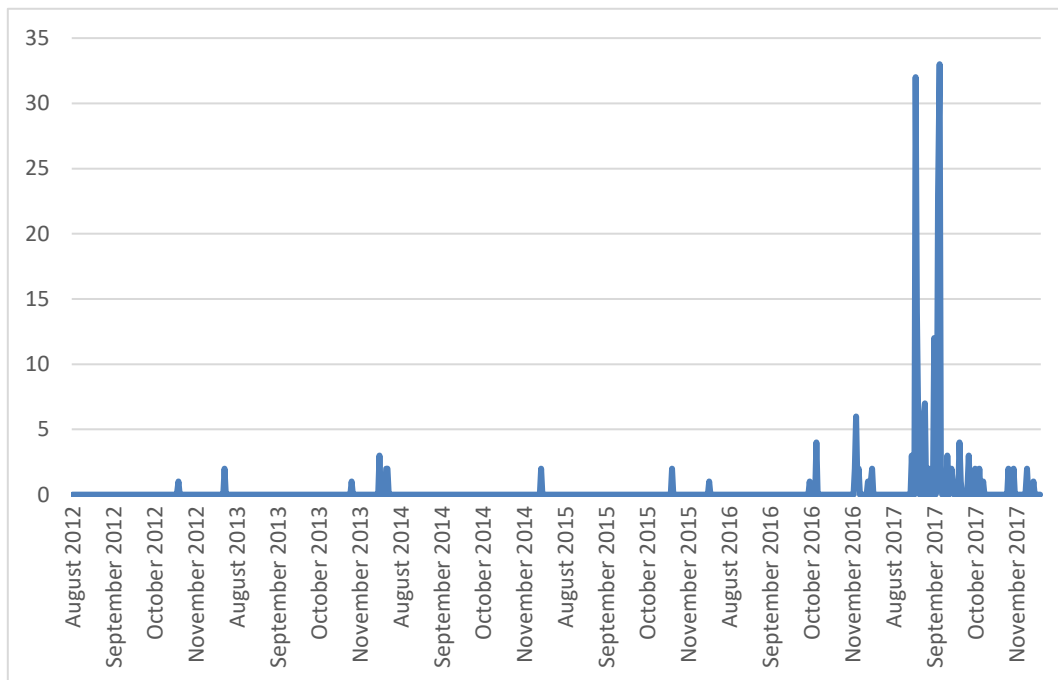
Figure 20: Daily sum of fires detected in the months of August through November, 2012 - 2017

This graph shows the daily totals of fire detections in the affected townships during the August through November period during the years 2012 through 2017. Fire detections during these months were rare in the affected townships until 2017, when large increases are observed.
